**ARBORIST
TREE PRESERVATION REPORT**

PROJECT NAME **MIDDLETOWN ELEMENTARY/MIDDLE SCHOOL
REPLACEMENT**

SITE LOCATION **MIDDLETOWN EDUCATIONAL CAMPUS
MIDDLETOWN, MD**

DATE **DECEMBER 12, 2023 (FIELD REVIEW 12.10.2023)**

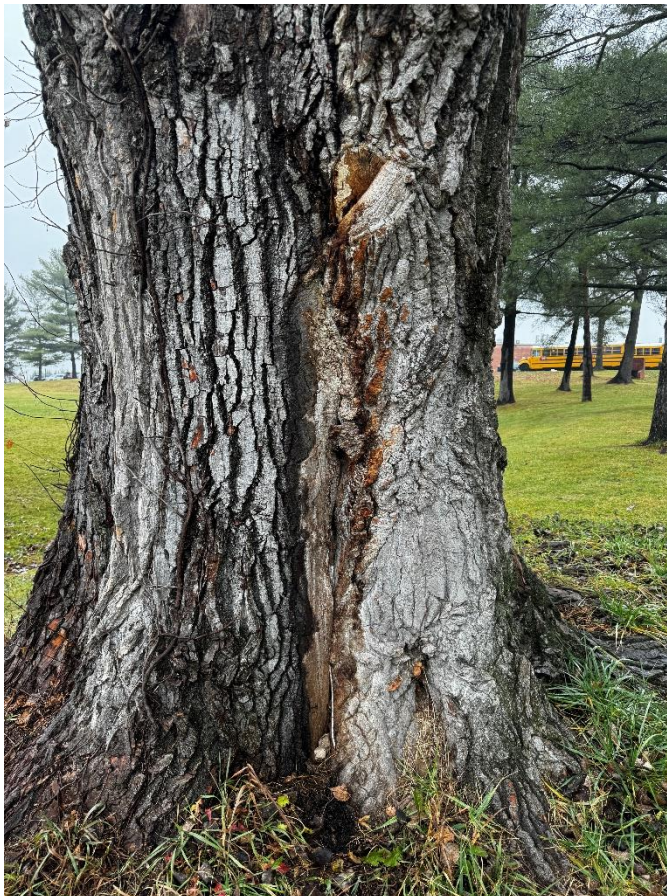
This tree appears to be maintained by a company or individual knowledgeable in tree care, given the cable system installed in the scaffold branches. Documentation of the tree and current care would provide insight into the health over the duration of monitoring. As the tree is currently, there are exposed/shallow roots that have mechanical damage likely from

mowers. The root flare appears to be a solid connection however, there is trunk damage shown in the photo. The area does not appear to be in active decay or soft wood but wound closure is not observed at this time. The damage does not appear to be impacting structural integrity of the trunk.

Root anchorage <u>GOOD ROOT ANCHOR</u>	Toxic gases/chemical symptoms
Collar/flare soundness	Presence of insects or disease
<u>Mechanical injury</u> <u>MOVER DAMAGE</u>	Mushrooms
Girdling/kinked roots	Other: <u>EXPLODED ROOTS / SHALLOW</u>
Compaction/waterlogged roots	
<u>3</u>	<u>3</u> = <u>6</u>
Structure (1-4)	Health (1-4) Subtotal (2-8)

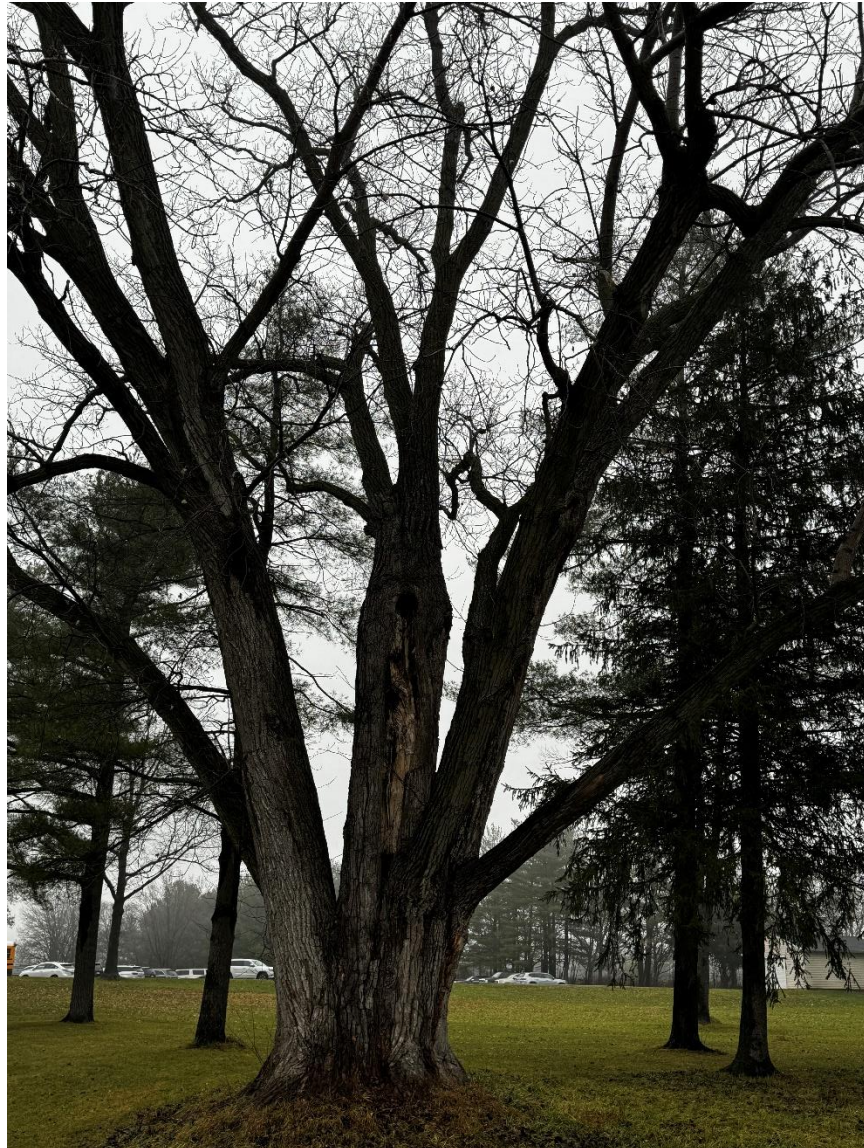
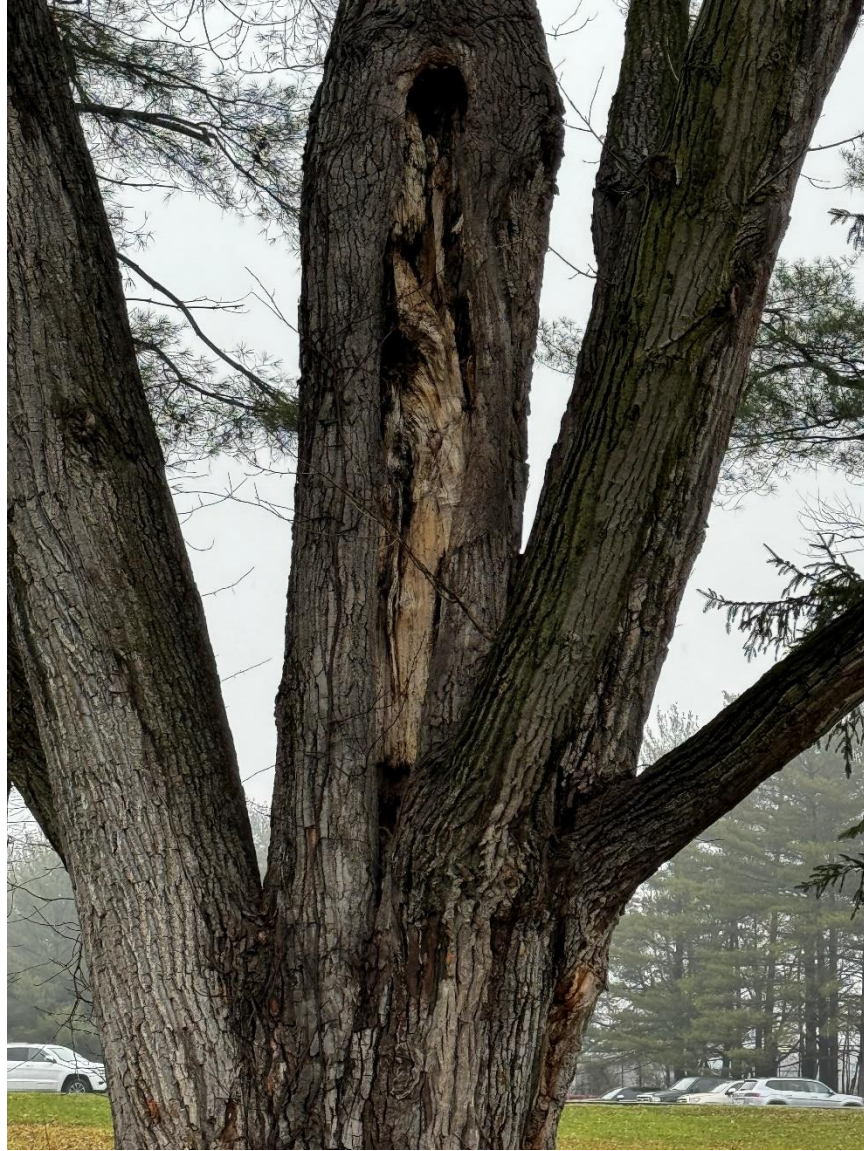
The area of concern is the large cavity in the main leader of the tree as depicted in the photographs below. From ground level the cavity appears to be approximately 30-40% of the leader diameter. The exposed cavity is approximately 10' in length. The cavity and area of exposure does not appear to be impacting the health of the tree based on fullness of canopy, good distribution of small branches and twigs.

Aside from the cavity, there do not appear to be visible health issues with the trees. There were no other symptoms of heart rot, such as fungus, dried or damaged wood. The cavity does not appear to be completely dried up and completely decayed.

The tree appears to be high fair/low good condition. Risk of tree failure could result in damage to the existing track or ballfield, but there do not appear to be structures, parking lots or high pedestrian traffic areas within the fall zone.

Sound bark or wood	Swollen or sunken areas
<u>Cavities</u>	Presence of insects or disease
Mechanical or fire injury	Conks
<u>Cracks</u> (frost or other)	Other: <u>LARGE CAVITY AT MAIN LEAD ON MAIN 35% CAVITY. CANNOT DETERMINE CAVITY DEPTH AT GROUND LEVEL. SMALL HOLE AT BASE</u>
	<u>2/3</u> <u>3</u> = <u>5/6</u>
	Structure (1-4) Health (1-4) Subtotal (2-8)

Further investigation utilizing climbing or aerial review of the cavity along with resistograph measuring the relative density of wood of the tree could provide more information to find out where the tree is in danger of failure at a weak spot that is undetectable from visual review. Review of the maintenance records of the tree would also provide insight into the health of the tree over the years.
