FREDERICK COUNTY PUBLIC SCHOOLS

Urbana Elementary School Feasibility Study

November 19, 2014

Crabtree, Rohrbaugh & Associates Architects

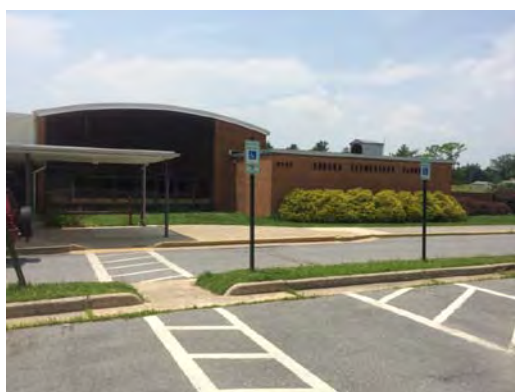
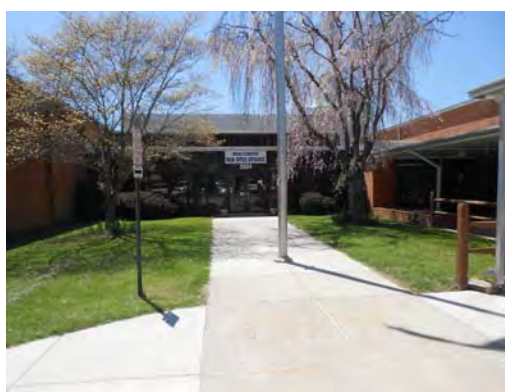
- The existing facility is not in compliance with current accessibility guidelines. Required accessibility upgrades include:
 - ✓ Room identification and interior signage
 - ✓ Door size
 - ✓ Door hardware
 - ✓ Water coolers
 - ✓ Toilet fixtures
 - ✓ Ramps
- Doors into existing toilet rooms in classroom areas do not meet the required width for ADA compliance nor do they meet the required height for code compliance. These doors and frames will have to be replaced and the openings reconfigured for compliance.
- The toilet rooms are very small and do not have the correct turn around clearances nor do they have the required clearances at the plumbing fixtures and door. Rooms will have to be renovated to be larger and ADA compliant.

- ❖ The main entrance to the building is accessible to someone in a wheel chair and includes an accessible curb cut along the main bus drop off area.

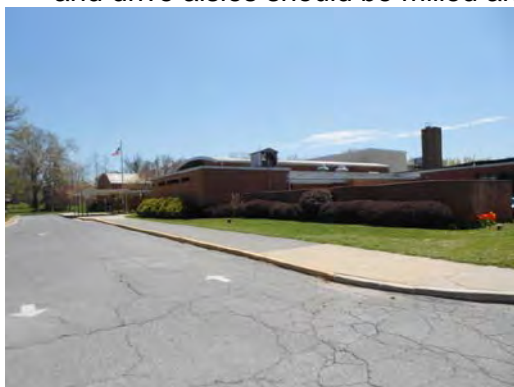
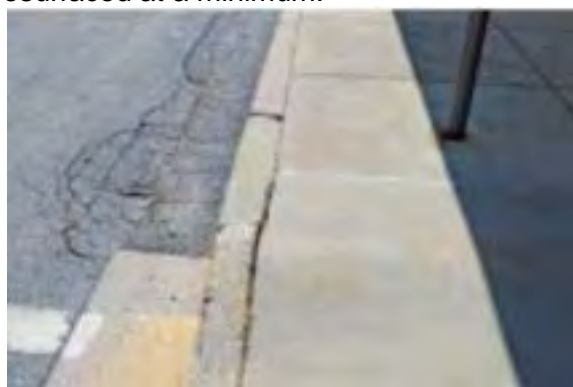
- Some repair / replacement of damaged sidewalk and curbing needed.
- Asphalt generally in fair condition, but is showing signs of cracking that will lead to compromise of the base course and foundation if not addressed. Paved parking and drive aisles should be milled and resurfaced at a minimum.

❖ Concrete and Asphalt Paving Conditions on Site

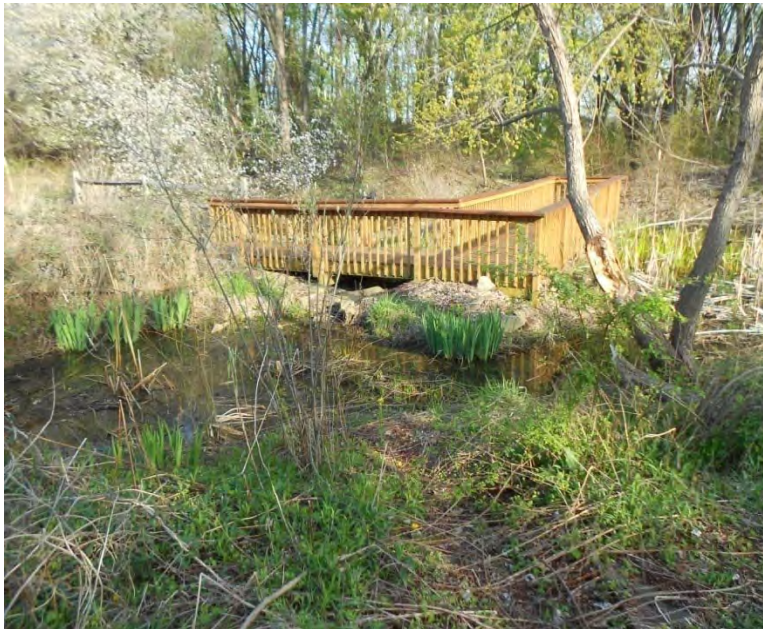
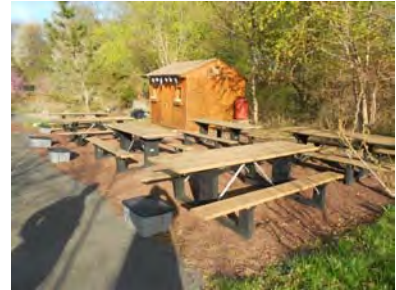
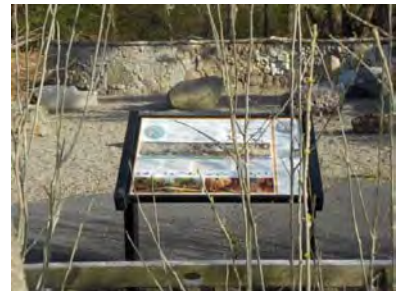
❖ Great Heron Wetlands

- Any new construction should also honor the existing Great Heron Wetlands and incorporate this extraordinary outdoor educational facility for continued use for future students and faculty.

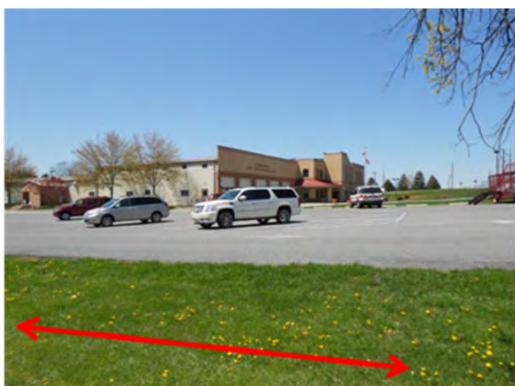
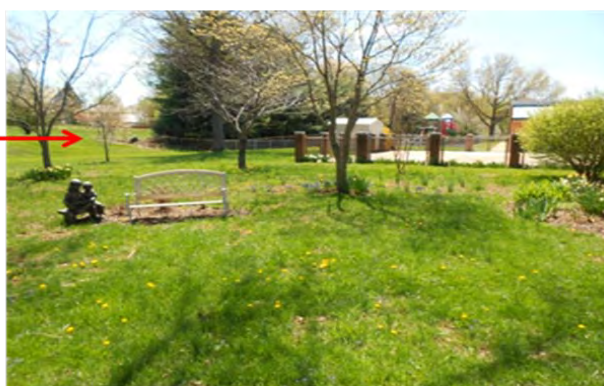
- Easements and Pipelines
 - There is a wide Gas Pipeline easement along the entire eastern and southern boundaries that further restricts access to the rear of the property.
 - There is a ten feet wide (10') gas easement along the fire department property with Frederick Gas company.

❖ Gas Line Easements

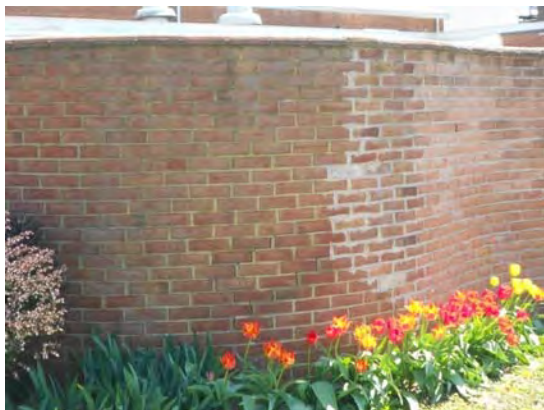
- The exterior of the building is mostly multiwythe face masonry and is generally in good condition, but with no insulation. There are some miscellaneous masonry repairs required and caulking necessary around windows and in masonry control joints. This work should be done in the short term in order to mitigate the possibility of water infiltration in these areas. In addition with any building project the masonry should be cleaned and sealed.
- There are various cracks in the concrete loading dock that should be repaired as part of any building project.

- ❖ The serpentine brick enclosure wall screening the loading dock area should be replaced as it is deteriorating due to moisture penetration and cracking. This would not meet today's code standards for construction based on when it was built and should be replaced.

- The serpentine brick enclosure wall screening the loading dock should be replaced as it would not meet current code requirements.
- Various cracks in the concrete loading dock should be repaired.

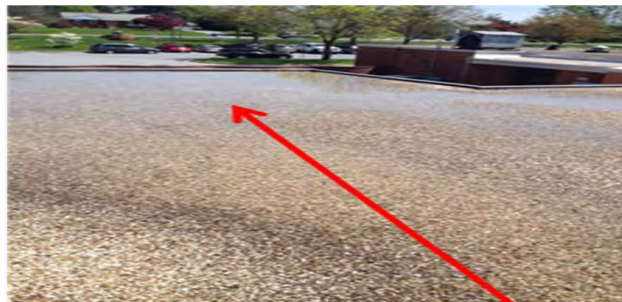
- Most of the existing roofs were re-roofed in 2003 with a built-up roofing system and are also in good condition. The roofs that were not part of that project, which include the areas over the Media Center and area over the west classrooms, Art Room, Mechanical Room and Kitchen, are in poor condition from water ponding on the roof. These areas should be replaced with any building project. The 2003 re-roofing projects should be evaluated at the time of the project to determine if they should also be replaced.
- The metal flashing, gutters and downspout systems appear to be in good condition.
- Leaks are common in nearly all weather events.
- There is a great deal of roof-top duct work on the west side of the building making repairs difficult. This is also the area where most ponding occurs.

West Side – Ponding

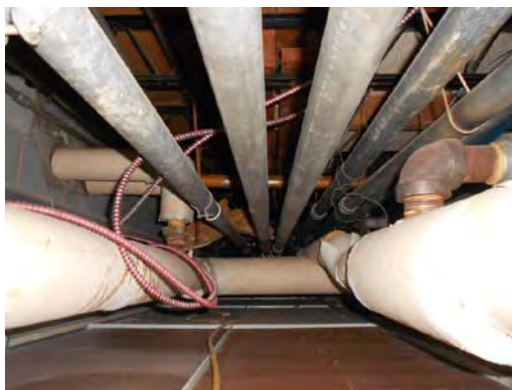
❖ Space Above Typical Ceiling

- In conjunction with mechanical and electrical improvements, the existing suspended ceiling tile and grid system should be replaced with a highly reflective tile in order to enhance and brighten the lighting quality. Provide "special" ceiling tiles in the Kitchen area where exposed to humid or damp conditions and where required by the Health Department. The ceiling heights throughout the classroom areas are fairly low and the light fixtures in these areas are surface mounted, as there is minimal space between the ceiling and bottom of roof structure. The recommendation is to recess the light fixtures, however, the challenge is that this would further decrease the ceiling heights.

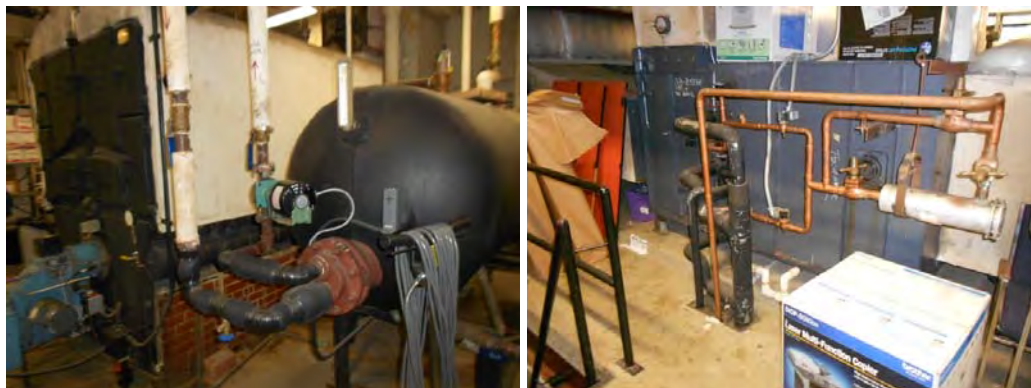
- The campus utilizes private water well for domestic water and an onsite septic disposal system.

❖ Existing Boilers and Water Service

- Domestic Water
 - Two (2) private water wells are located in front of the building. The well supply lines enter a vault in front of the main building which is the head room for both the domestic water tank. A single hatch and ships ladder is the means to access this confined space. The domestic water tank is hydro-pneumatic (pressurized by an air compressor) type. It is original to the 1965 construction and connects to the building via an underground galvanized pipe. Domestic hot water is generated by the boiler utilizing a storage tank with integral tank heat exchanger. The water lines are original and in failing conditions requiring on-going repairs/partial replacement.

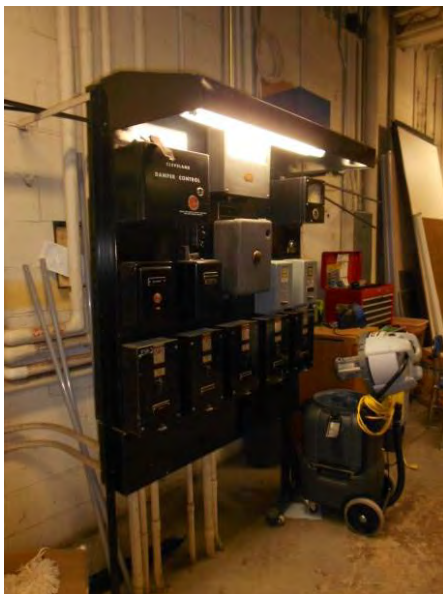
- Existing Systems
 - Electrical Service
 - The electric service is 2000A, 480/277 volt, 3-phase, 4-wire via a utility pad-mount transformer. The meter is located on the exterior of the building outside the Boiler Room. The main switchboard, located in the Boiler Room, is manufactured by Federal Pacific (FPE) and dates to 1976.

- An overhead three phase utility primary feeder extends from the street to a pole directly across the parking area from the pad-mount transformer. The primary feeder extends from the pole underground to the transformer. A single phase feeder continues overhead to a 167kVA, 120/240V single phase pole mounted utility transformer serving the portable classrooms behind the building.

- ❖ A 2000A, 208/120V, 3-phase, 4-wire FPE switchboard is located immediately adjacent to the main switchboard, served by a 500kVA dry type transformer in the room directly behind wall. This switchboard serves local lighting and receptacle panelboards throughout the building. The building lighting, as well as the kitchen equipment, are fed from the 208/120V distribution system. HVAC equipment is fed at 480/277V.

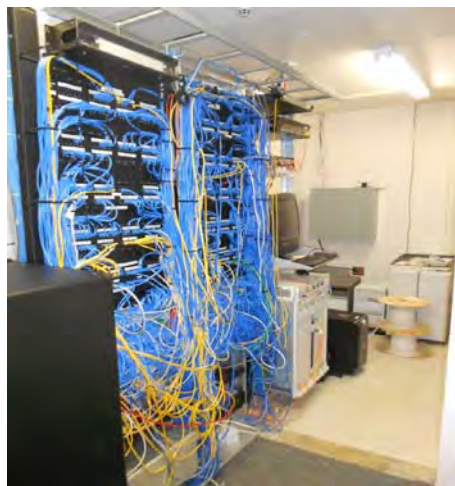
- Technology/ Security Systems
 - The telecommunications systems infrastructure includes an overhead service via pole lines then transitions underground from the pole to underground conduits near the utility transformer. The telephone and cable television services enter the building on the same wall as the existing gas meter near the boiler room.

- ❖ Currently, there exists one (1) MDF. The MDF contains multiple 48 port patch panels. Category 5 data cabling, installed around 2000, is provided throughout the school.
